Rent Roll

Properties: 1000 Chelwood Park Blvd. NE Albuquerque, NM 87112

Duke City Inspections, LLC was retained for a survey of the building main sewer line in an effort to identify areas of suspect clogs or damage and to document the areas for further review. Further investigations of these areas or destructive testing may reveal additional conditions that were not readily visible at time of inspection. This report is based on information obtained at the site at the given date and time. We document our findings with videos and visual photographs of the areas. The purpose of any sewer scan service is to document problems in sewer lines. Our inspection is designed to comply with accepted industry standards when at all possible and will be performed in a non-destructive manner, however at times destructive testing may be necessary. Our inspection is not meant to be a guarantee of all affected areas; only those that reveal themselves to our sewer camera, visual inspection and our experience.

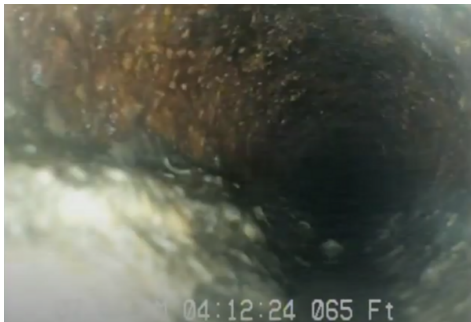
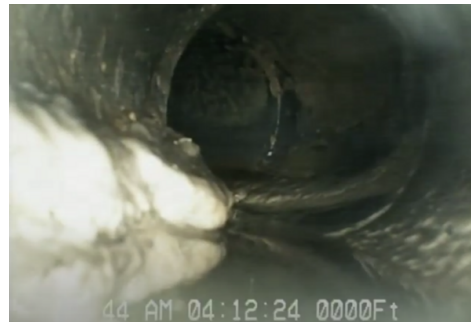
There is scale and grease build up inside sewer line which will promote clogging. We recommend clearing the line as needed by a licensed plumber and rescoping to confirm proper function.

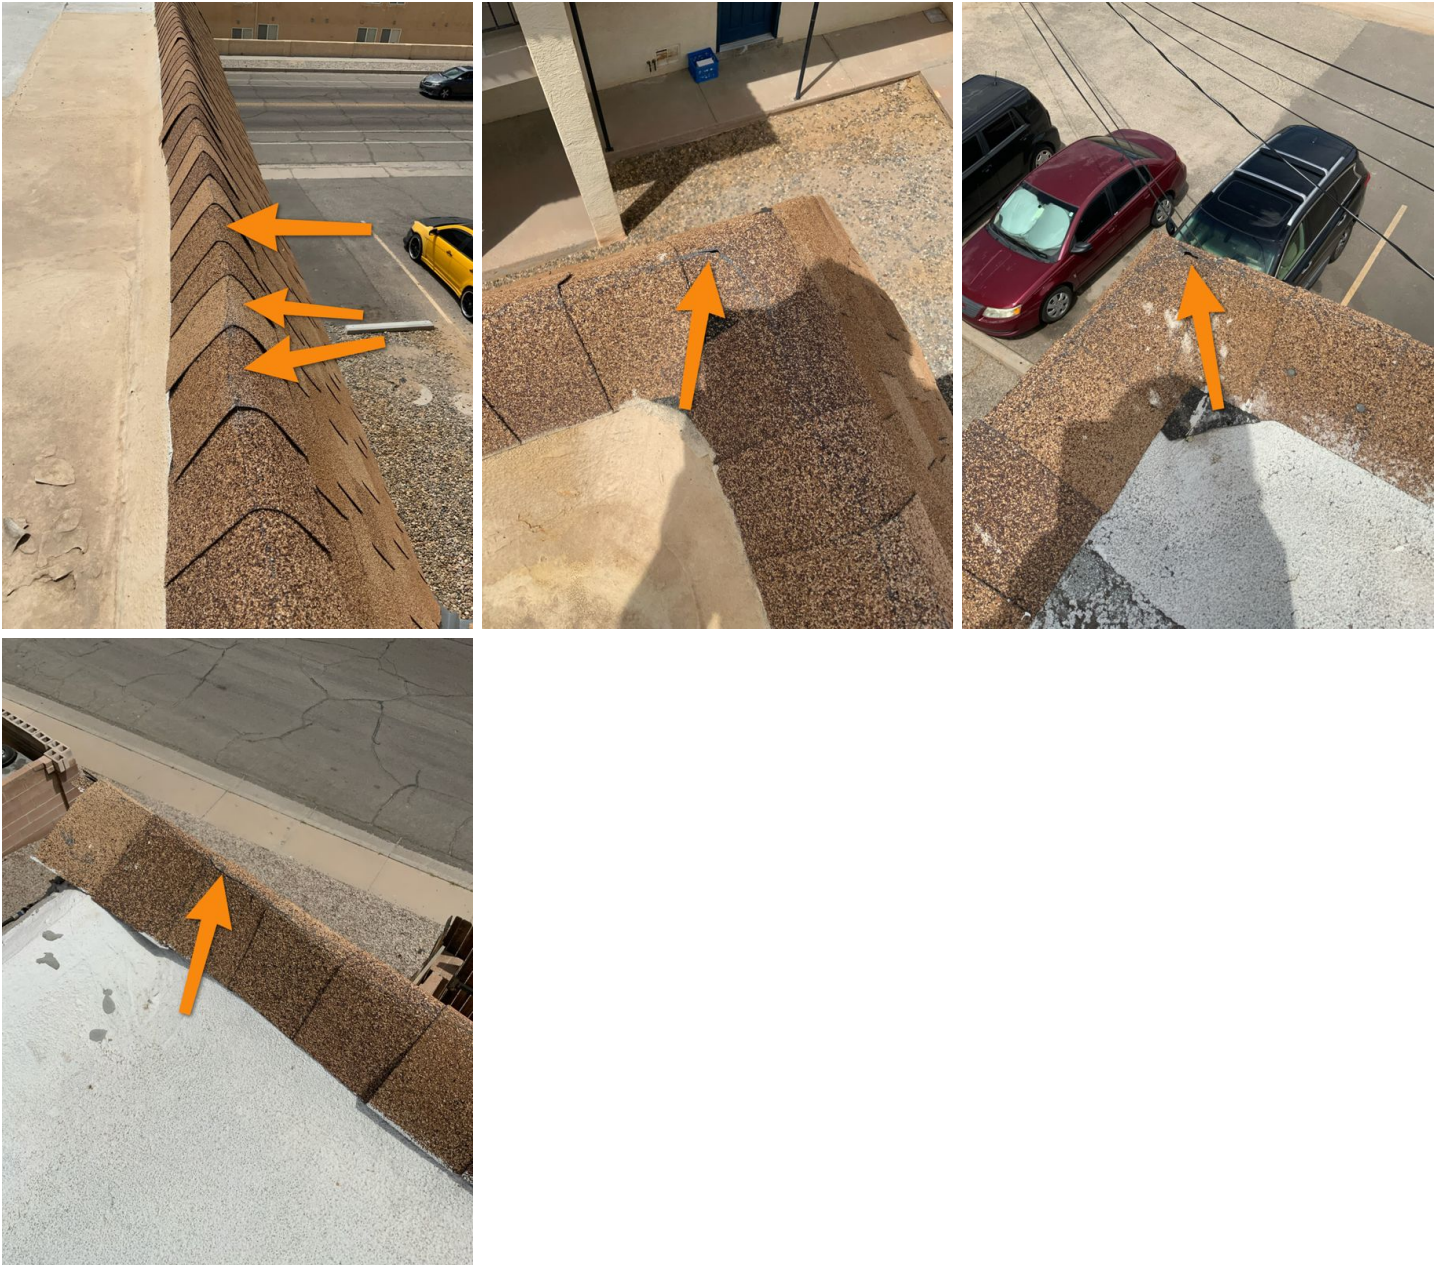
COMPOSITION SHINGLES DAMAGED OR MISSING

Some composition shingles were damaged. Leaks can occur as a result. This is a conducive condition for wood-destroying organisms. Photos are a reference to the condition, more damage may exist. Recommend that a licensed roofer repair as necessary. For example, by replacing shingles.

Recommendation

Contact a qualified professional.

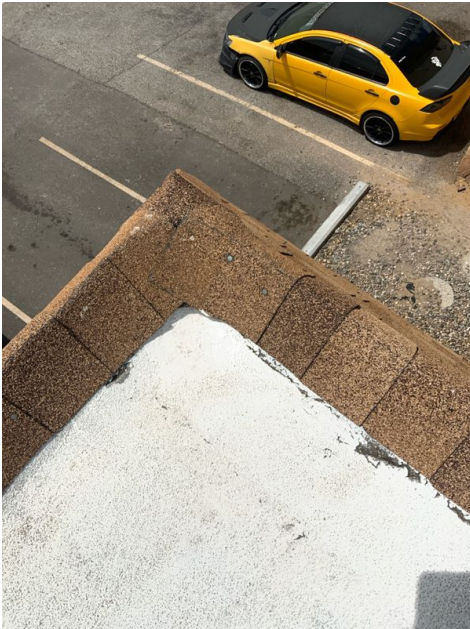
2.3.1 Bitumen / Torchdown

ROOFING DETERIORATED

Contact a qualified professional.

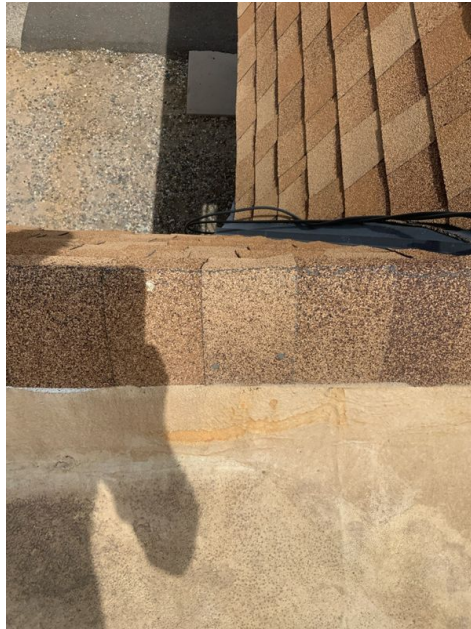
2.2.2 Shingles / Shakes

COMPOSITION - EXPOSED NAIL HEADS

Nail heads were exposed at shingles. Typically a sealant is applied to nail heads to prevent leaks. Recommend repair by a qualified person.

Recommendation

Contact a qualified professional.

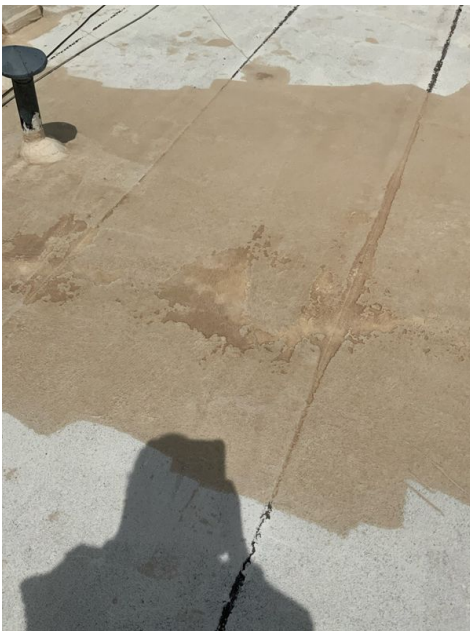
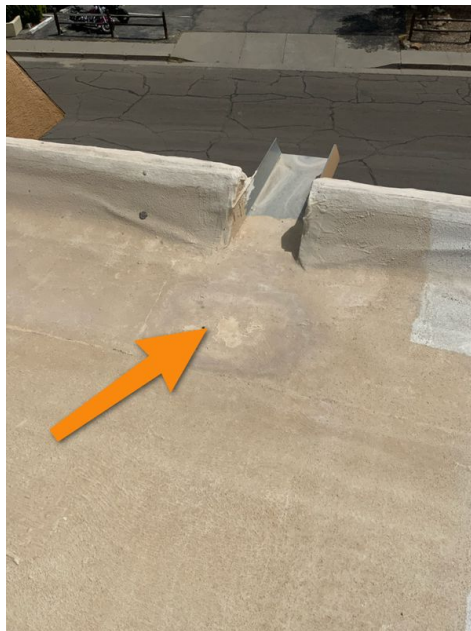
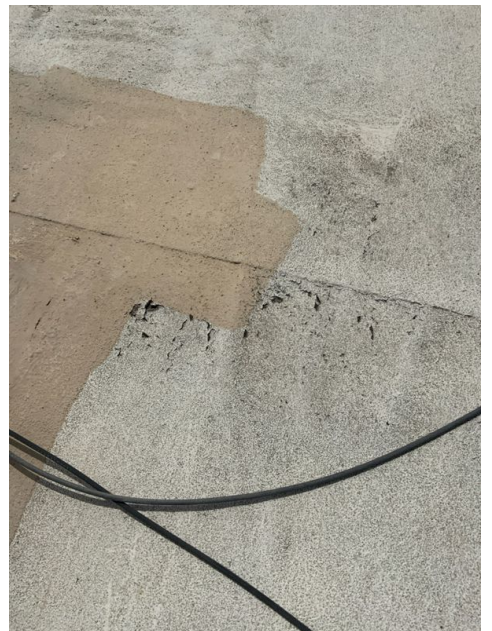
The topper product on the flat or low-slope roof surface was deteriorated/failing. Recommend further evaluation and correction by a licensed roofing contractor.

Recommendation

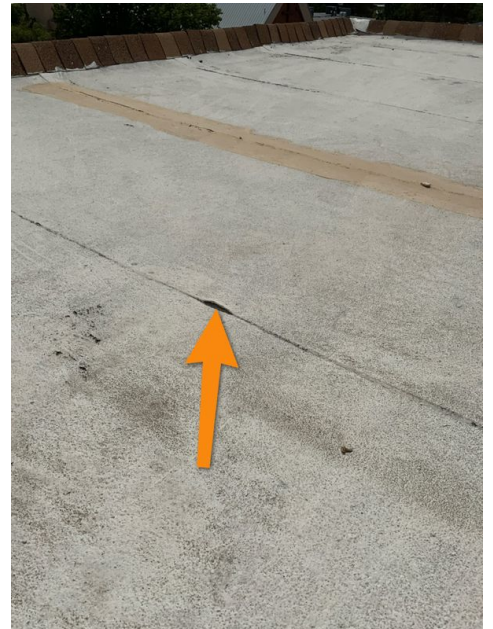
2.3.2 Bitumen / Torchdown

GAPS, OPEN CRACKS, HOLES

Gaps were found in the bitumen roof surface at seams. Recommend repair by a licensed roofer.

Recommendation

Contact a qualified professional.

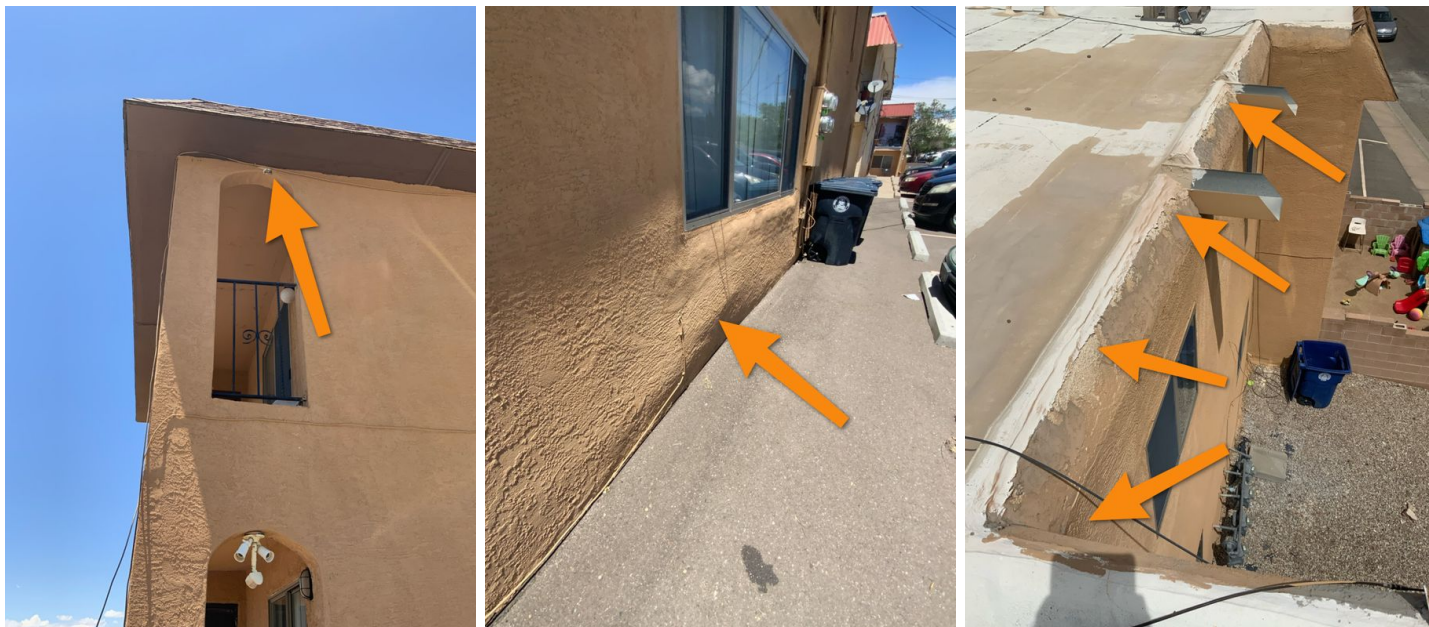
REPAIR STUCCO

Recommendation

Contact a qualified professional.

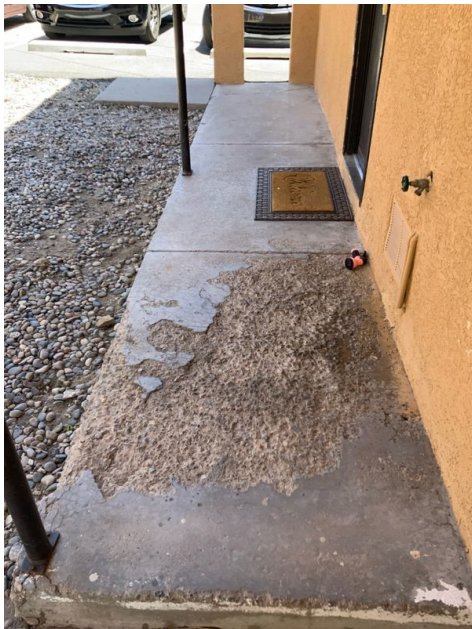
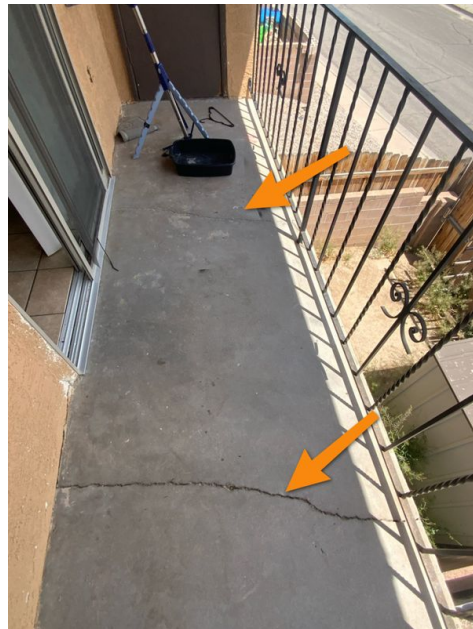
Unit C

CONCRETE - CRACKING AND DETERIORATION

Contact a qualified concrete contractor.

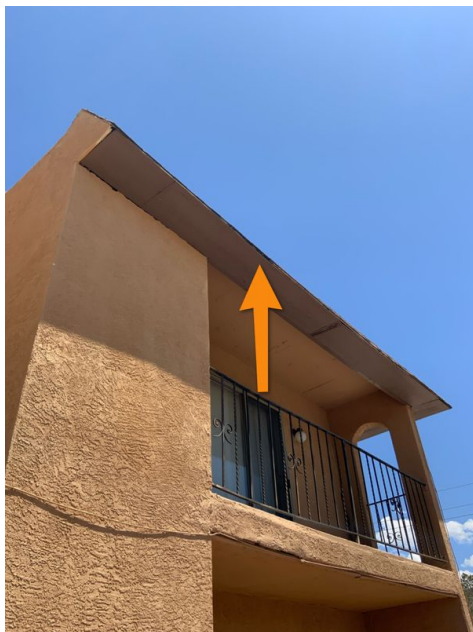
3.4.1 Soffits & Fascia

SOFFIT/FASCIA - MOISTURE DAMAGE

Recommendation

Contact a qualified siding specialist.

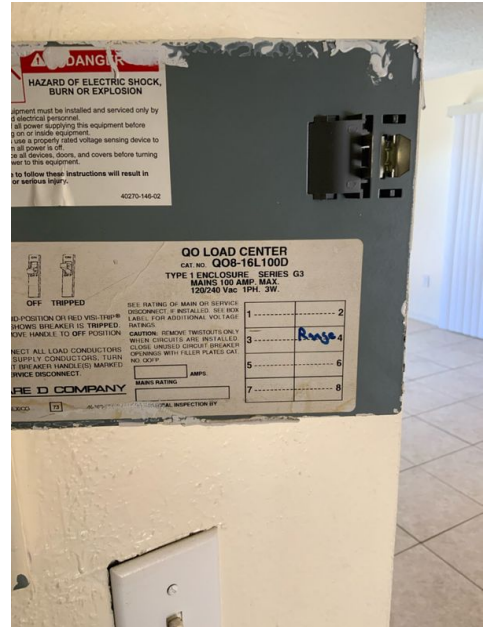
8.2.2 Sub Panel

UNDERSIZED WIRE

Contact a qualified electrical contractor.

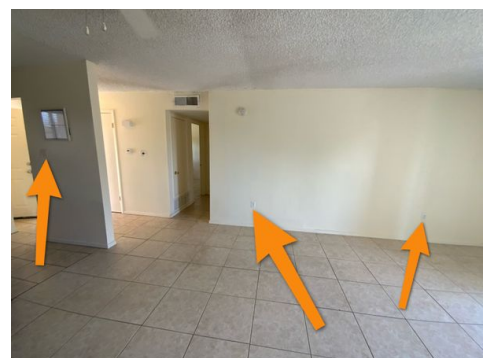
8.6.1 Lighting / Fans

LIGHT FIXTURE - IN NEED OF REPAIR

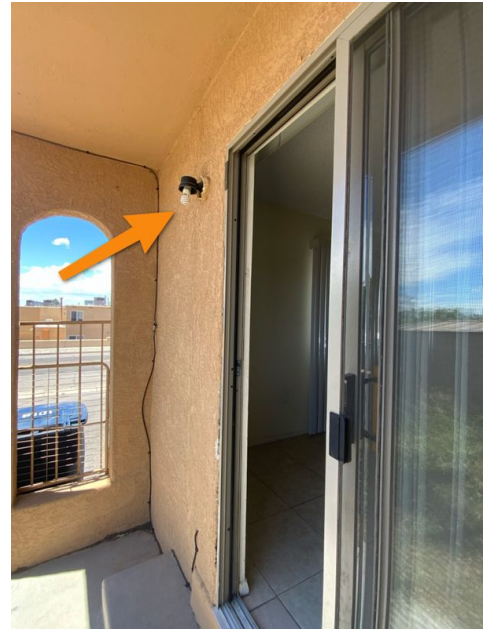
8.4.1 Receptacles

RECEPTACLE - OPEN GROUND

Recommendation

Contact a qualified electrical contractor.

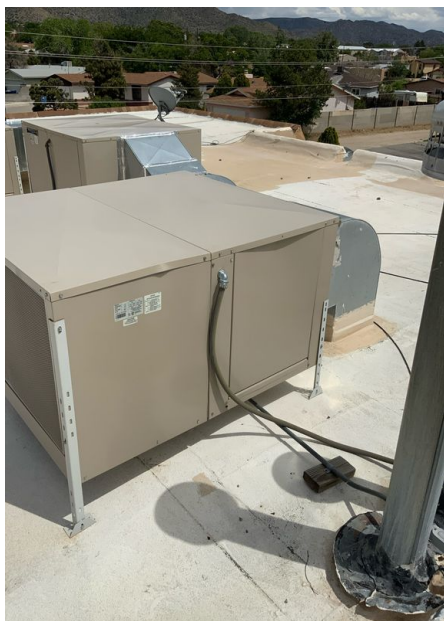
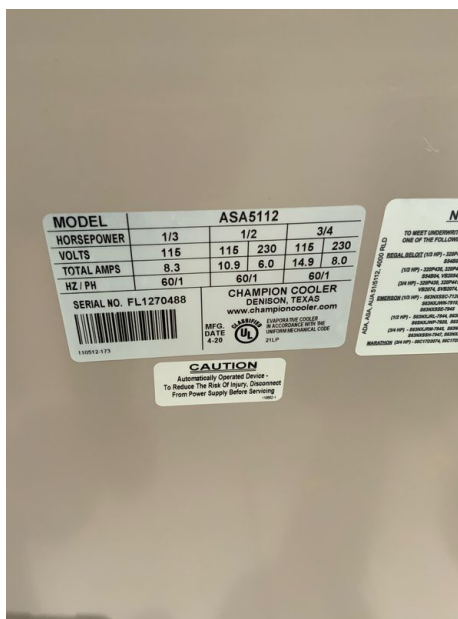
MODEL	ASA5112					
HORSEPOWER	1/3	1/2		3/4		
VOLTS	115	115	230	115	230	
TOTAL AMPS	8.3	10.9	6.0	14.9	8.0	
HZ / PH	60/1		60/1		60/1

SERIAL NO. FL1270488
 CHAMPION COOLER
 DENSON, TEXAS
 www.championcooler.com
 MFG. DATE: 4-20 21LP

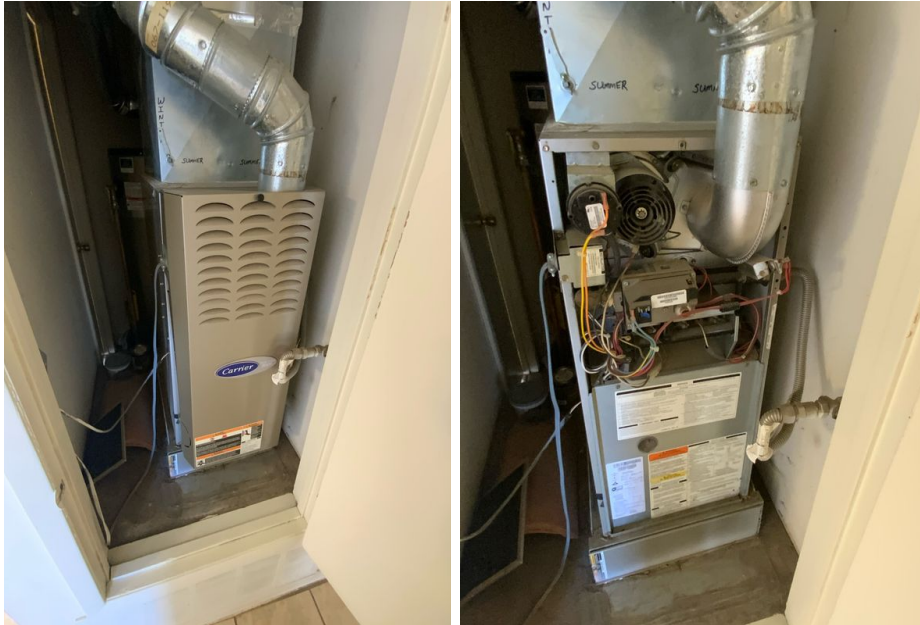
The evaporative cooler was not fully evaluated because the unit was winterized. Recommend that a full evaluation be made by a qualified person when conditions have been corrected so the system is operable. Note that the inspector does not operate or replace over current protection devices, or operate any controls other than normal controls (thermostat).

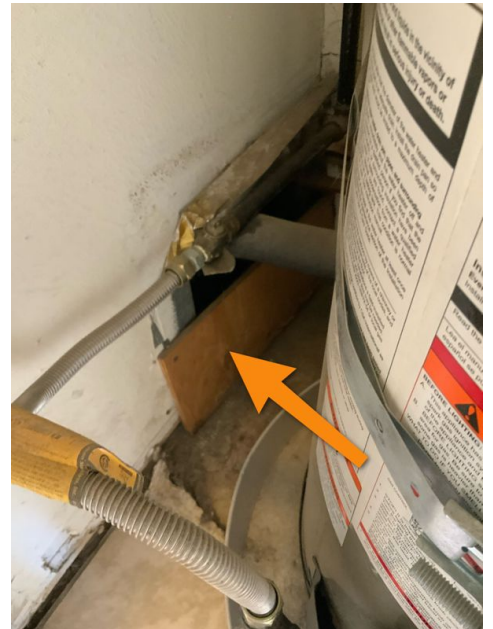
Combustion air was blocked. This can result in improper combustion and reduced air quality. Recommend repair by a qualified person.

Contact a qualified professional.

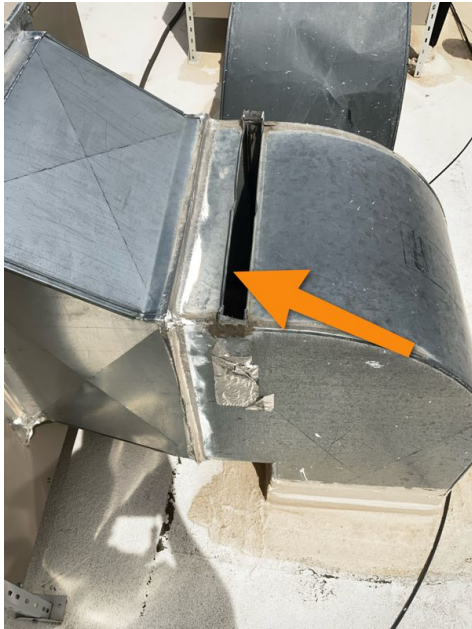
12.9.1 Evaporative Cooler
DAMPER DOOR

Damper door was missing at the evaporative cooler. This result in reduced heating efficiency in the winter. Recommend repair by a qualified person.

Contact a qualified professional.

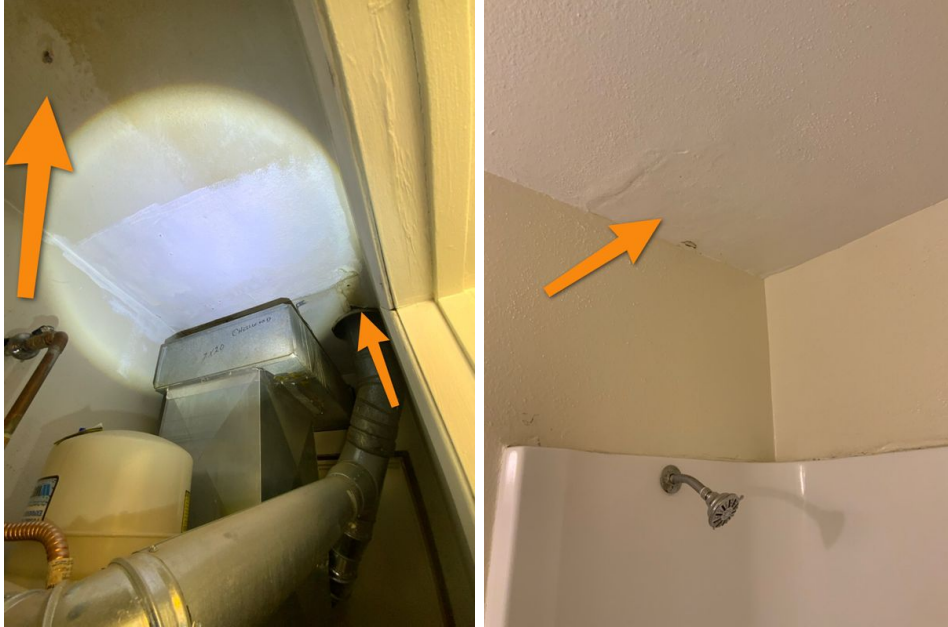
CEILING - DRY STAINS, MONITOR

Stains with no elevated levels of moisture were found in ceiling areas. This may be due to a previous plumbing/roof leak. Recommend monitoring and repairing as necessary if leaks persist.

Contact a qualified professional.

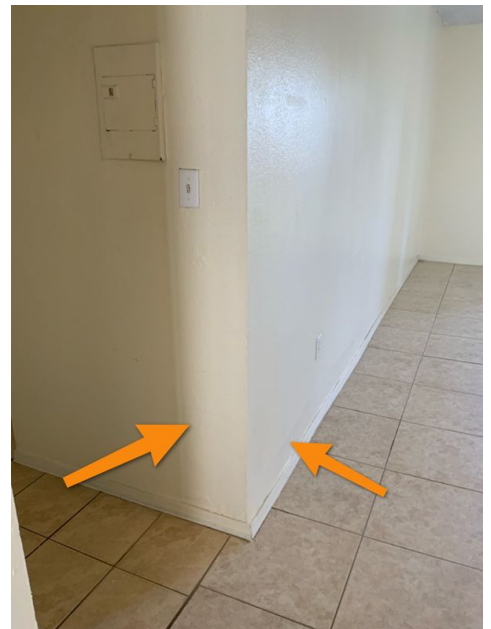
14.5.2 Walls, Ceilings and Fixtures

SUBSTANDARD PATCH AND PAINT REPAIRS

There are many substandard patch and paint repairs throughout all the units. Photos are a representation of the condition. Recommend sending down and reapplying texture and paint.

Contact a qualified professional.

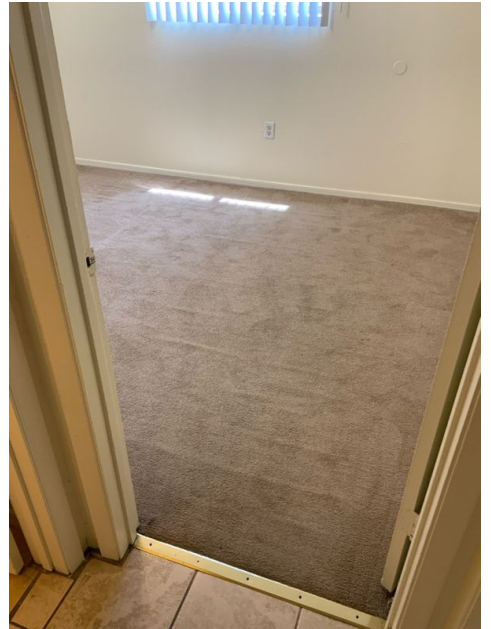
14.6.1 Floors

CARPET LOOSE

Carpet was loose/well worn in areas. Recommend repair/replacement by a qualified person.

Contact a qualified professional.

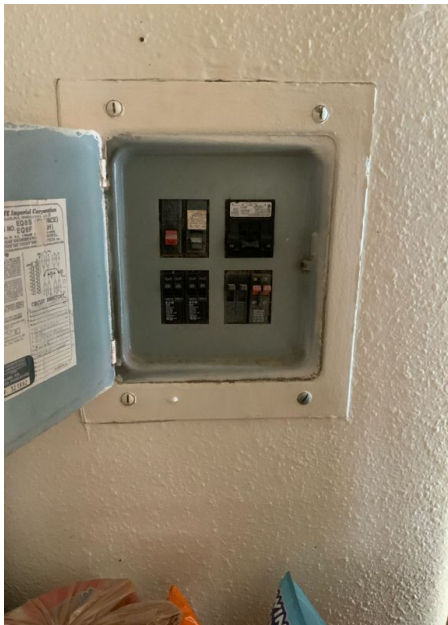
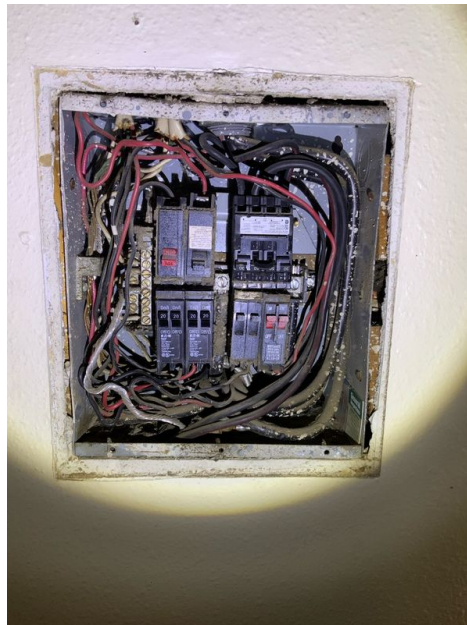
BUSHING - MISSING

The wires enters the service panel through a knockout and is not protected by a bushing or strain clamp. The metal edges of the service panel can damage the wire insulation and cause a short and shock hazard. I recommend the installation of a bushing or strain clamp by a qualified electrician.

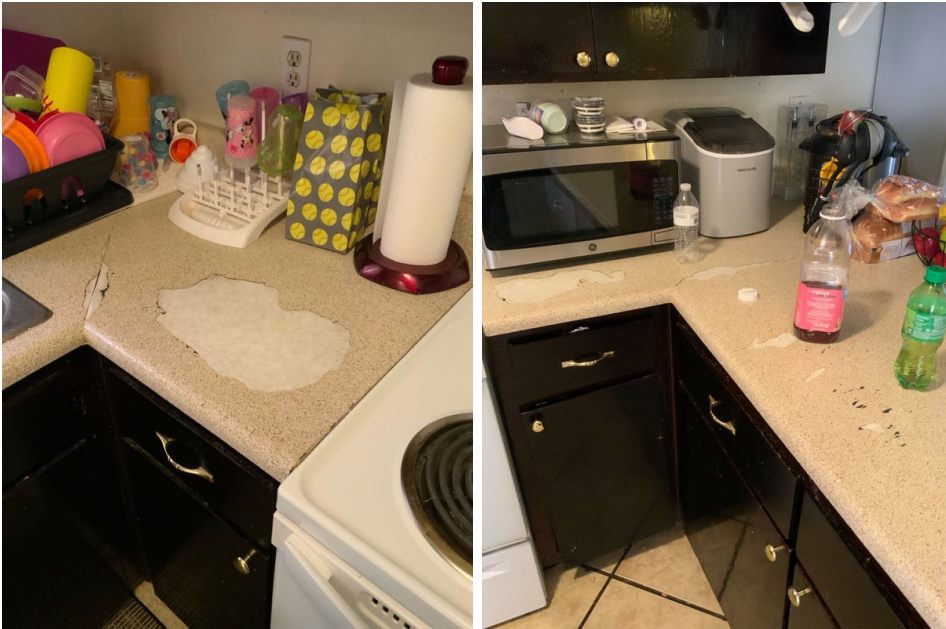
COUNTERS, BACKSPLASH DAMAGED, DETERIORATED

Counter tops and/or back splashes were damaged or deteriorated. Recommend repair / replacement by a qualified person.

Contact a qualified handyman.

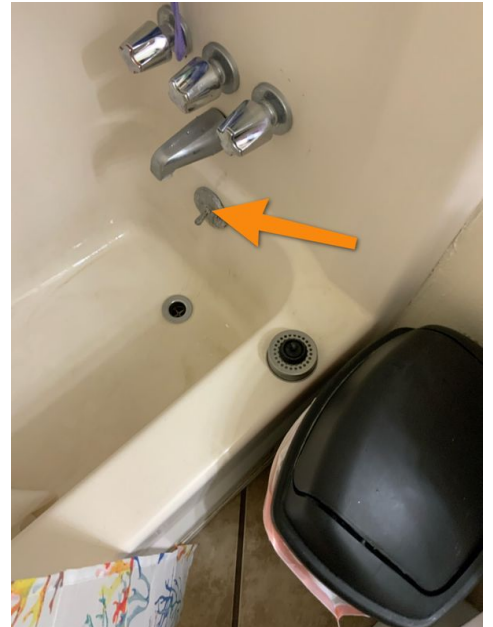
Deficiencies**DRAIN STOPPER**

The drain stopper was missing or inoperable. Recommend repair by a qualified person.

Contact a qualified professional.

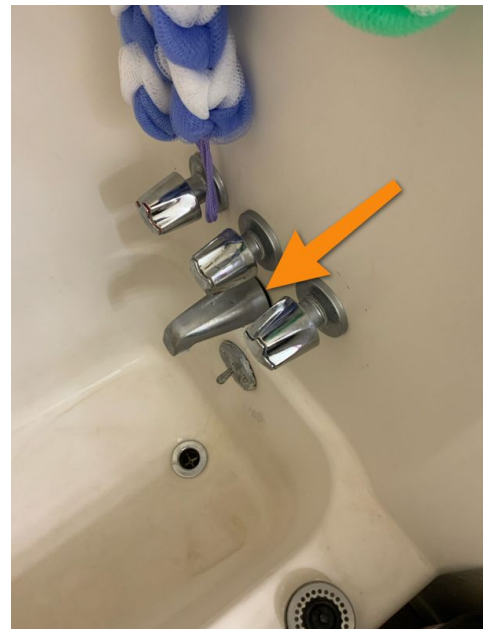
17.7.2 Bathtubs

Deficiencies**GAP OR NO CAULK BEHIND SPOUT**

Caulk was missing behind the bathtub spout or there was a gap behind it. This can result in water intrusion behind the wall as a result. Recommend caulking as necessary by a qualified person. For gaps larger than 1/4 inch, recommend installing an escutcheon.

Contact a qualified professional.

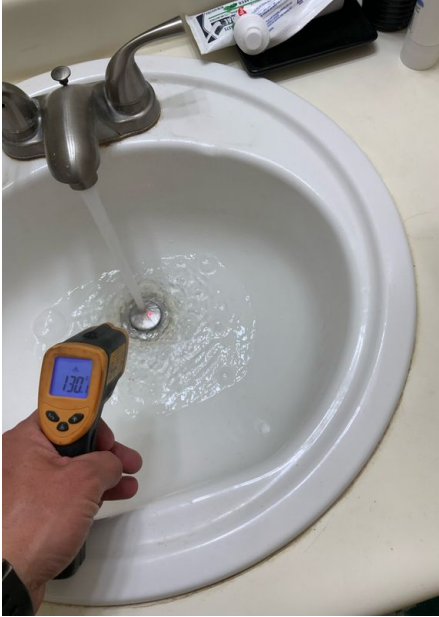
130

Temp: Hot

Temperature distributed from the water heater was greater than 120 degrees at fixtures. This can pose a burn or scald hazard especially for children. Recommend turning water heater thermostat down to 120 degrees F or less.

Recommended DIY Project

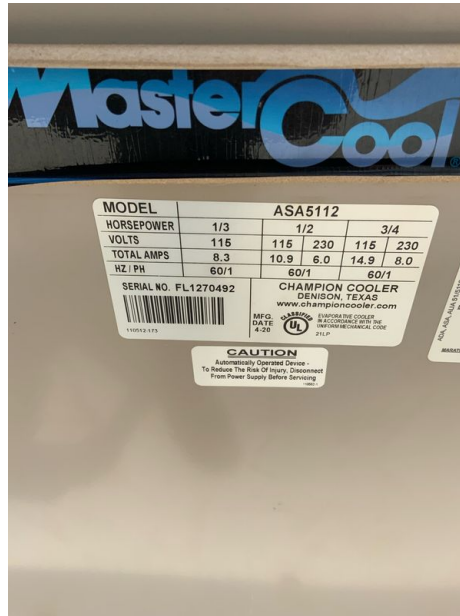
MODEL	ASA5112					
HORSEPOWER	1/3	1/2		3/4		
VOLTS	115	115	230	115	230	
TOTAL AMPS	8.3	10.9	6.0	14.9	8.0	
HZ / PH	60/1			60/1		
SERIAL NO.	FL1270492					
CHAMPION COOLER DENISON, TEXAS www.championcooler.com		MFG. DATE: 4/1/2020				
11093-127		UL LISTED

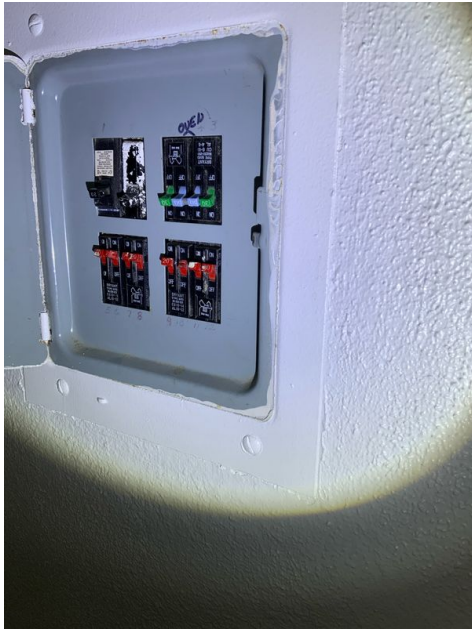
UNABLE TO INSPECT - PAINTED SCREWS

Due to the screws that hold the deadfront on being painted, I was not able to remove the deadfront and thoroughly inspect the sub panel.

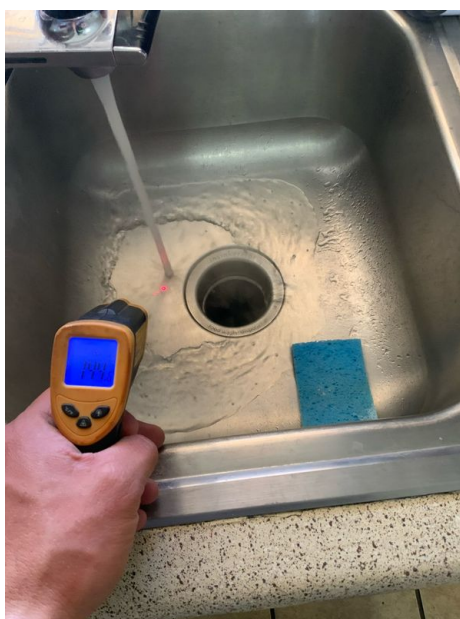
Temperature distributed from the water heater was greater than 120 degrees at fixtures. This can pose a burn or scald hazard especially for children. Recommend turning water heater thermostat down to 120 degrees F or less.

Recommended DIY Project

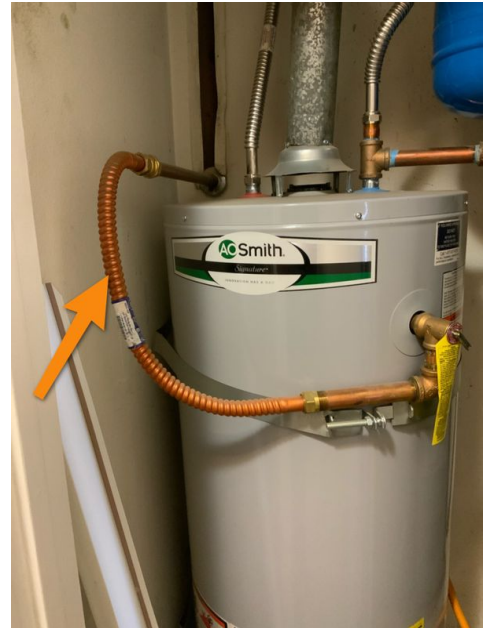
25.8.1 Flues

Deficiencies**FLUE - IMPROPER SLOPE**

Flue is angled down. All flues should be angled up to allow exhaust fumes to exit properly. This is a dangerous situation that could allow carbon monoxide to back draft into the house. Recommend further evaluation and correction by a qualified contractor.

Contact a qualified professional.

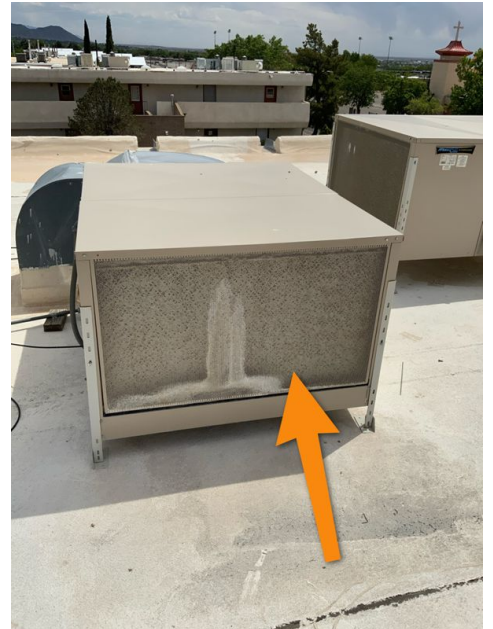
The evaporative cooler had significant amounts of calcium build up. This will shorten the lifespan of the cooler. Recommend further evaluation and correction by a qualified contractor.

Contact a qualified professional.

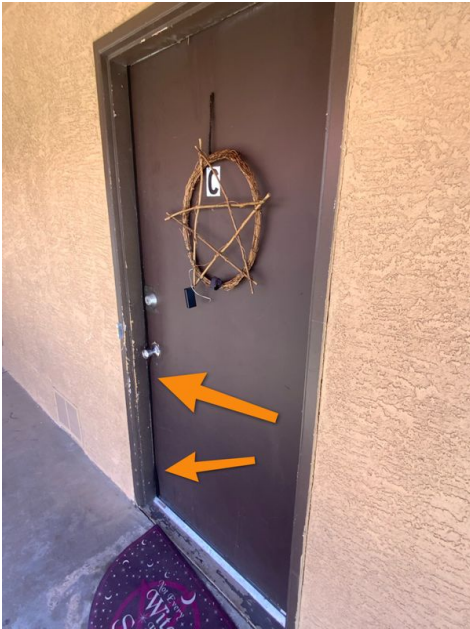
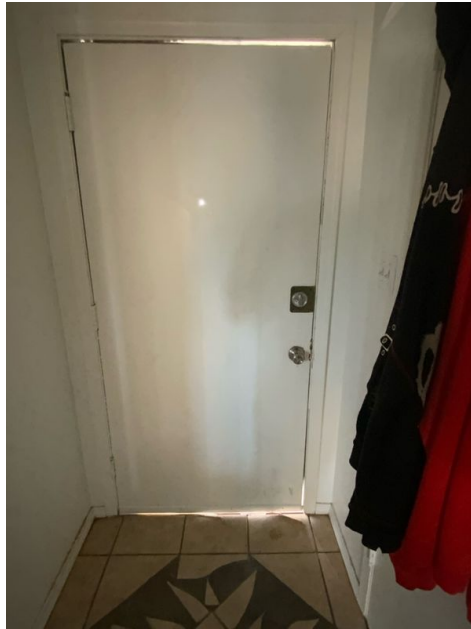
28.2.2 Exterior Doors

DAMAGE

Exterior doors were damaged/deteriorated. Recommend further evaluation and correction by a qualified contractor.

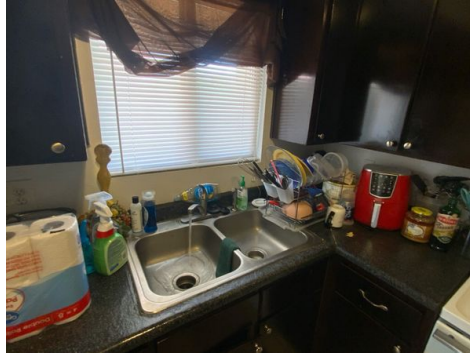
The receptacles were not GFCI protected. In order to protect against electrical shock, I recommend having all receptacles in the garage, on the exterior, and near any water sources protected by GFCI receptacles. I recommend having the receptacles evaluated and addressed as necessary by a licensed electrician.

Contact a qualified electrical contractor.

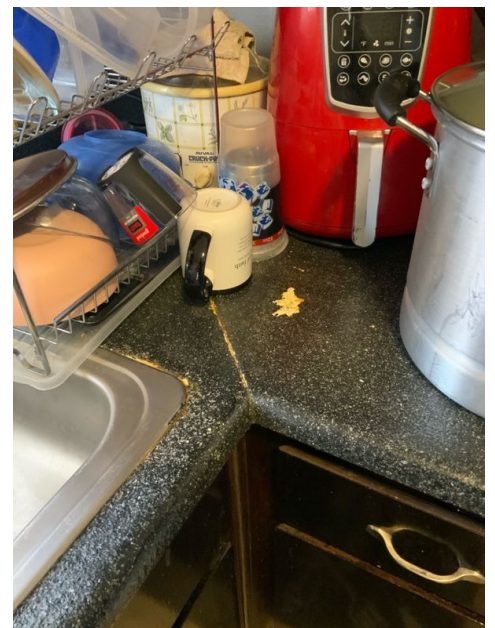
30.3.1 Cabinets

CABINETS, DRAWERS, DOORS DAMAGED, DETERIORATED

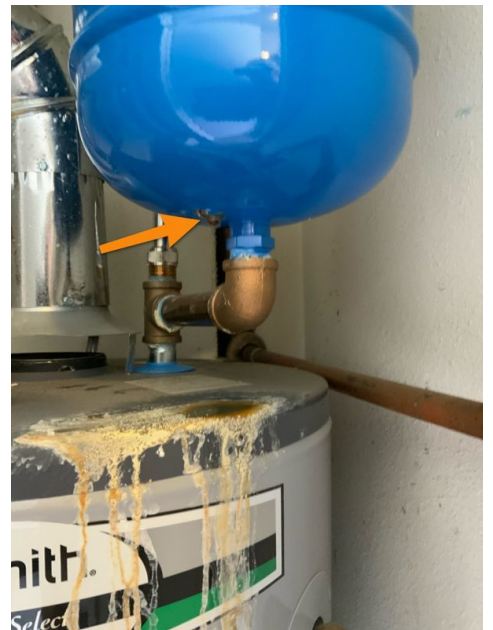
32.3.1 Temp

> 120

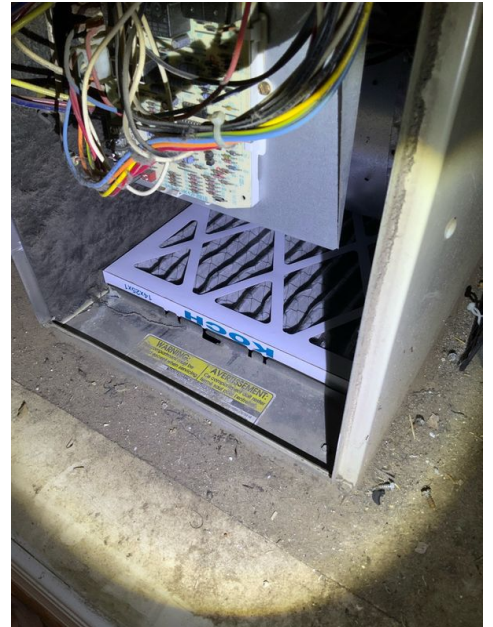
Recommend a qualified person to repair or replace the filter brackets or filter system.

Contact a qualified professional.

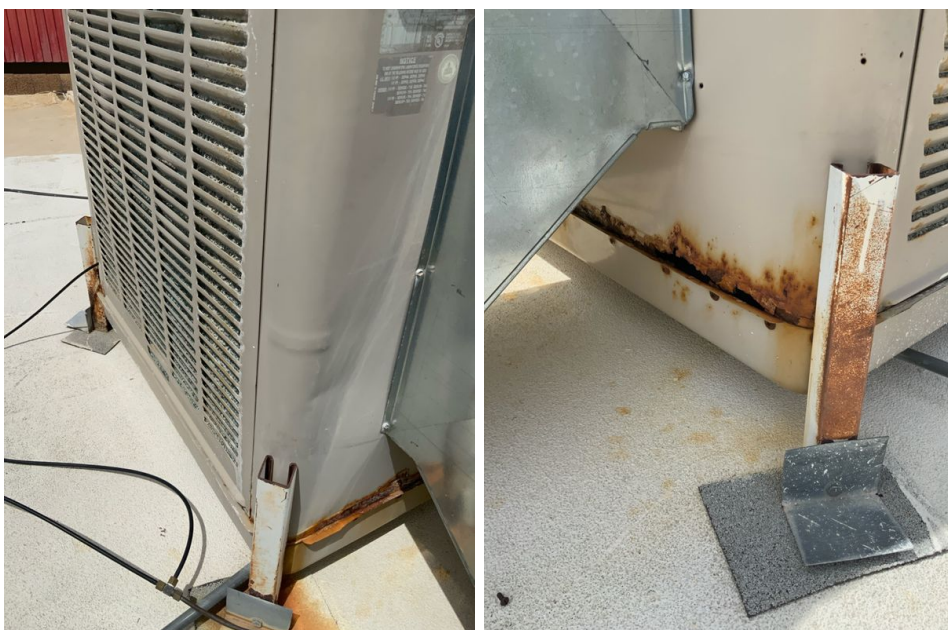
RUST

There is rust on the evaporative cooler. Recommend further evaluation and correction by a qualified contractor.

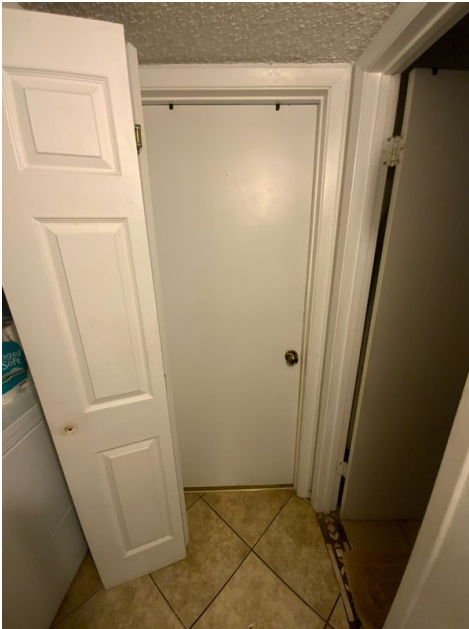
ROOM LOCKED

A bedroom door was locked at the time of inspection. This room is excluded from the inspection as a result.

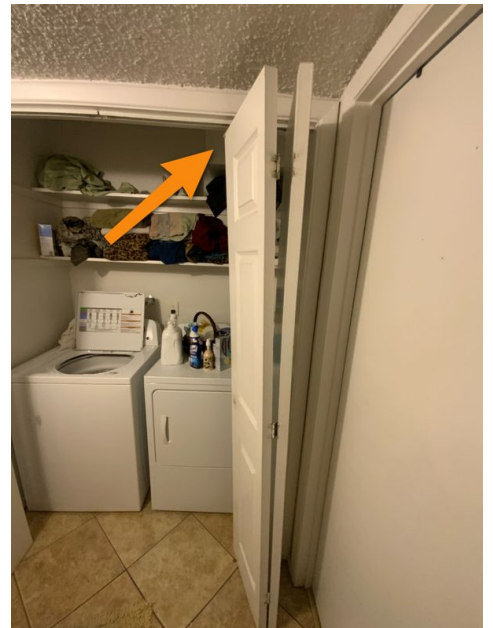
35.3.1 Interior Doors

Interior doors were damaged/ not functioning properly. Recommend repair by a qualified person.

Contact a qualified professional.

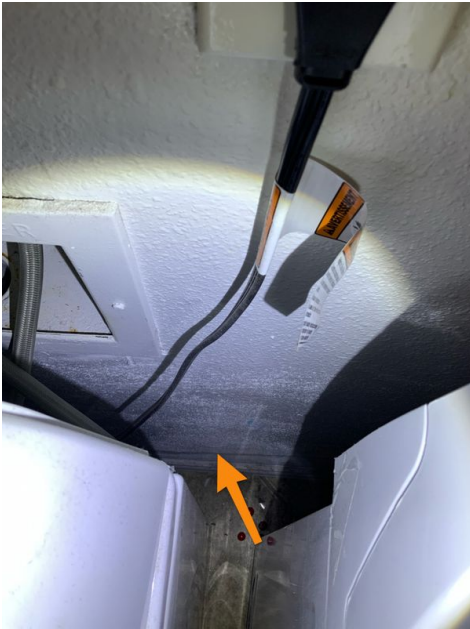
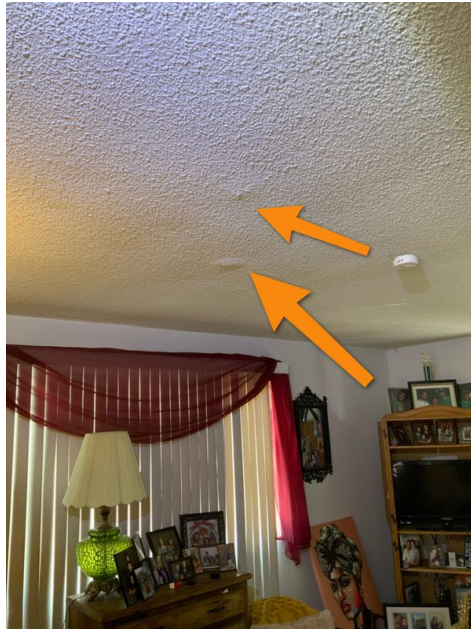
CEILING - DRY STAINS, MONITOR

Stains were observed in ceiling areas but no elevated moisture was found. Recommend monitoring areas in the future especially after rains.

Contact a qualified professional.

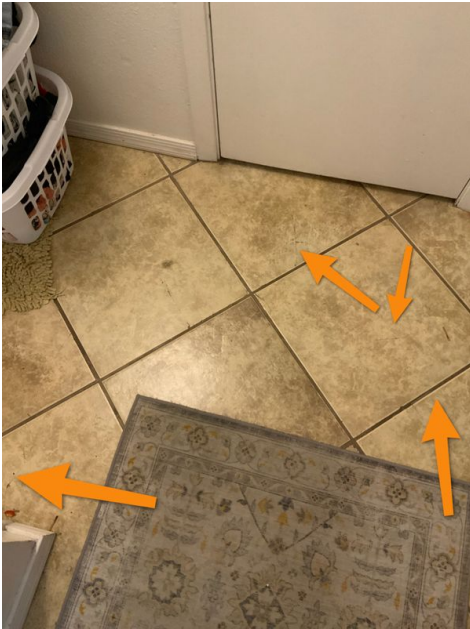
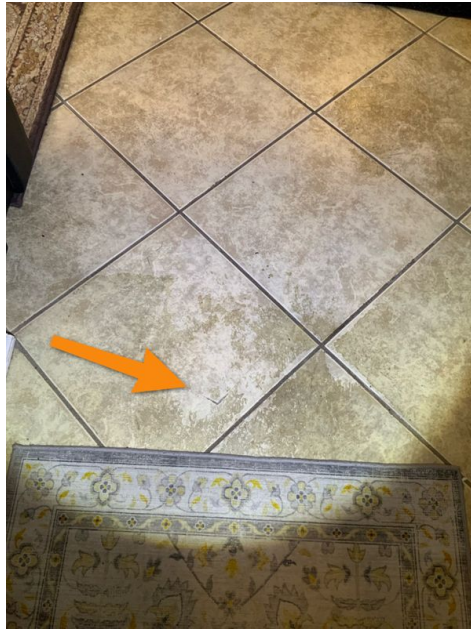
TILE OR STONE IS DETERIORATED, NEEDS REPAIR

Tile and/or grout was cracked, loose or deteriorated in areas. Recommend repair by a qualified person.

Contact a qualified professional.
